# TEL GEZER EXCAVATIONS 2007

## FIELD A: PRELIMINARY FIELD REPORT

By Dr. Gary P. Arbino, Field Archaeologist

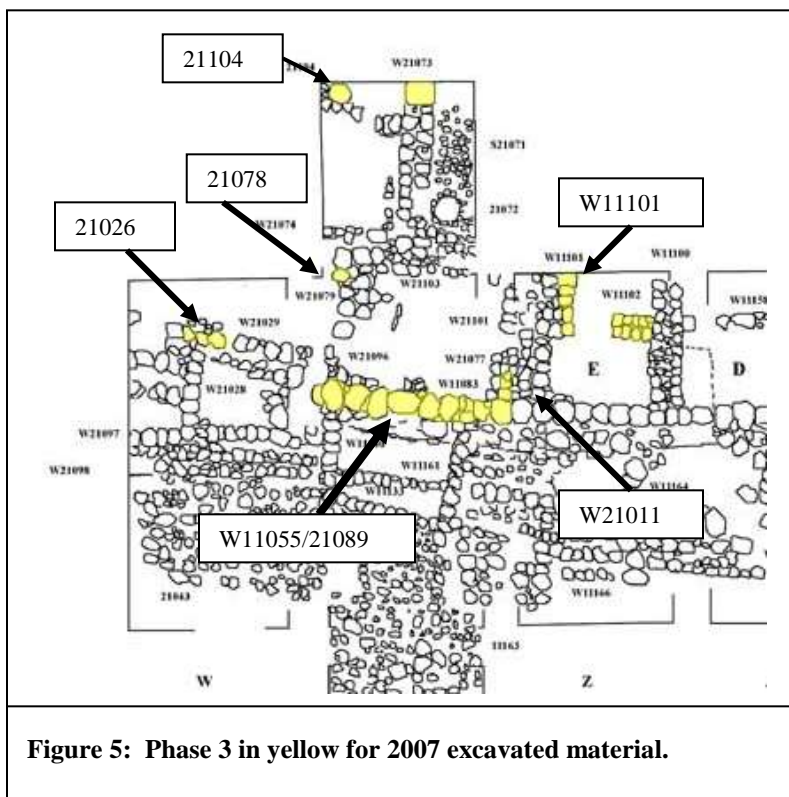
**Figure 5: Phase 3 in yellow for 2007 excavated material.**

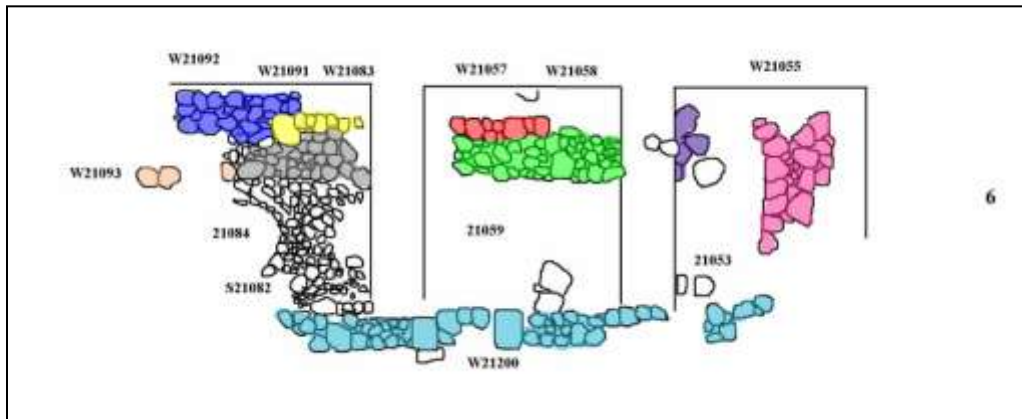
**Figure 7: Remains in C6, D6 and E6. W21093 (light tan), W21083 (grey), W21091 (yellow), W21092 (blue), W21058 (green), W21057 (red), W21055 (magenta), W21200 (light blue). Also Silo 21084 (east side) and cobble surface (S21082) in C6.**

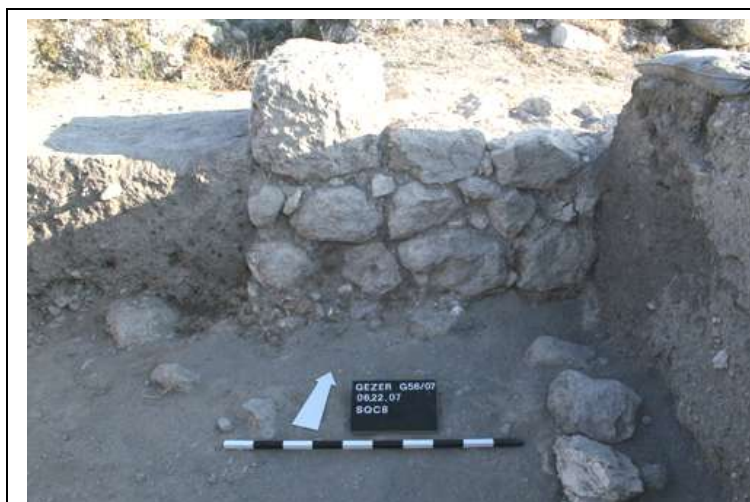
**Figure 8: North balk of C8 showing W21099. Note that it is above W11142 extending south to north in the right of the picture (Photo 20070621\_2327).**

Almost 5 meters south of the north wall system (in the south balk of these squares) is another east-west wall unit (numbered W21200 in the off season) which is constructed of pillar bases (set approximately 2m apart) with two to three rows of stones in between each. There are two pillar bases, perhaps three. This wall line extends from midway in C6 eastward to midway in E6. It is less extant in E6. It was not excavated in 2007, but was cleaned off. This wall is parallel to what appears to be a mirror wall system north of C8 and D8. These have not been excavated, but during cleanup in C8 to remove a collapsed balk, the south face of one of these sections (W21099) was exposed (Figure 8).

The exposure reveals that the walls containing the pillar bases are deeply founded indicating that they were designed to support considerable weight. Thus when viewed as a whole unit this building was substantial. The cobble surface found in C6 (S21082) compares well to the small portion of cobble surface (S11027) in C8. This indicates that the outer aisles of this building were cobbled, even though no cobbles have been found in D6 or E6.

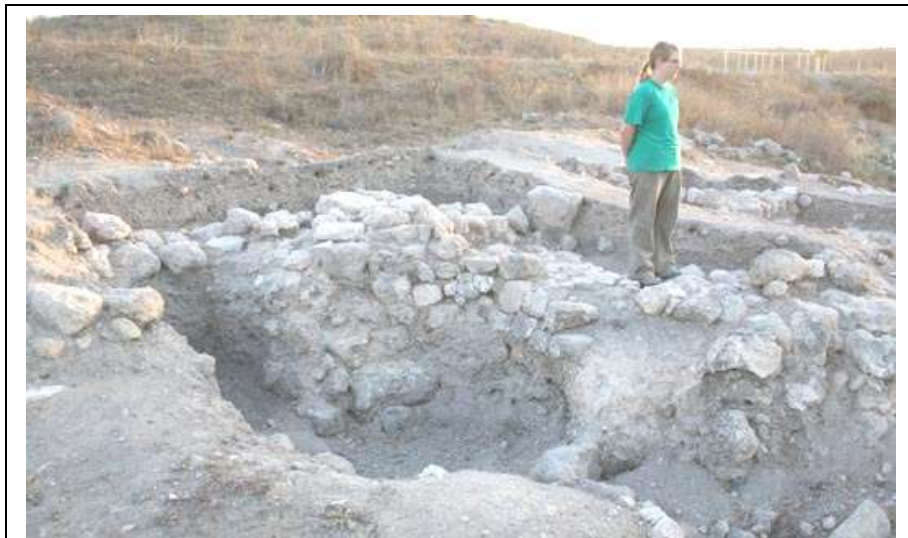
**Figure 9: View eastward looking into the Silo (21084) in C6, which was previously excavated by Dever. Mendy Loyd is standing on the cobble surface (S21082). Photo 20070718\_3396.**

A silo (21084), or specifically the remaining east half (1.3m wide), was found in the northwest section (C6). It was lipped with stones (similar to the smaller one of the same phase in Y7 – 21072) and was lined with flat cobble sized stones. It is extant to a depth of

about 1.2m, (see Figure 9) but it is not possible to determine if this is the actual bottom of the silo or simply where Dever excavations ceased to dig, having possibly gone through the bottom of the silo. The condition of this silo is currently too poor to make any guess as to possible use.

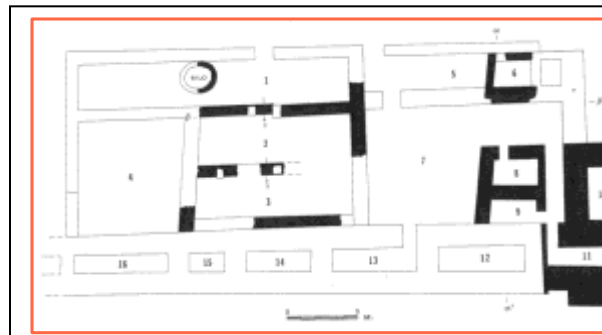
**Figure 10: Dever's "Palace 8000" plan from 1984/1990.**

A comparison of these three plans (Macalister, Dever, Gezer 2007) shows some major differences between Macalister and the more modern ones. The silo as noted above shows the east side instead of the west and seems to have a wall running through it. Is this because he excavated the west half and did not find the east side? He did find the north wall and the gap that is on the plans of both Dever and Gezer 2007. He also found W21055 and W11146. Dever shows these in outline on his plan indicating he took these from the Macalister plan. Dever posits that the west side wall did not continue north of the north pillar base wall (W21200). The Gezer 2007 plan indicates that the west wall might have angled westward, thus solving the problem.

Macalister’s plan shows the northern pillar base wall (W21200) as an offset wall, which (correctly) Dever shows as straight. Dever draws the pillar bases in the south pillar base wall (W21099). We also shows the two main bases in W21200. Dever’s plan indicates that he excavated the western end of W21200 and that it connected with a continuation of W211055, but does not connect it to W11146. If his drawing is correct, there was no opening in the eastern wall (as Macalister also indicates).

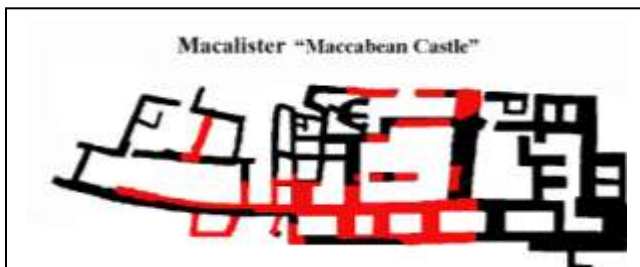
**Figure 11: Macalister's "Maccabean Castle" plan.**

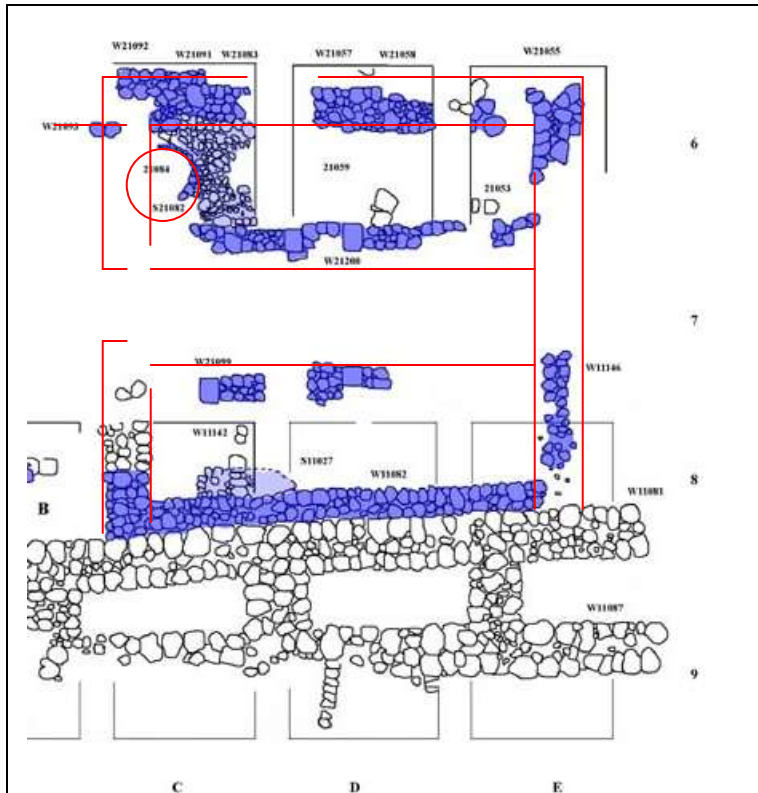
**Figure 12: The extant remains of Building A (in blue). The casemate wall system to the south would have been reused as would the wall (W11144) extending northward from C8.**

This large building is connected with the gate complex and should be considered to have had an administrative or public function. It seems to have had no entrance on the east side, so the opening must be assumed to have been on the west wall.

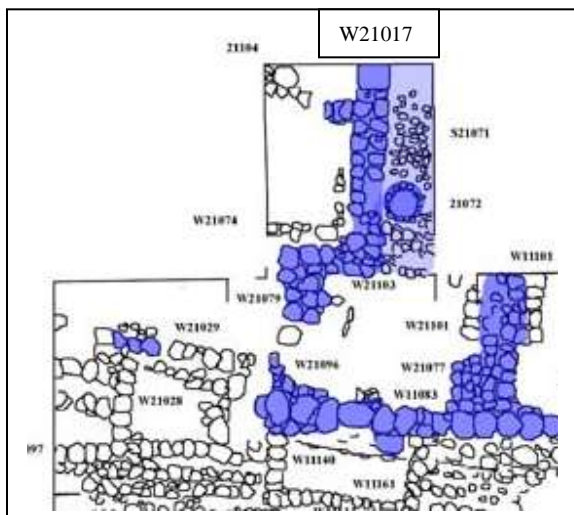
**Figure 13: Phase 6 remains (blue) from Squares Y7, Y8 and W8 .**

In Square Y7, the west portion of a room was uncovered. The destruction debris sealing part of this room confirm the phasing of this room. The room is bounded on the west by wall W21017. This wall is a two row wall of small boulders which was founded on smaller socle stones. A portion of the wall is missing, most likely having been excavated by Macalister (although possible destruction debris [21076] was found in the ‘gap’ that may relate to 21019).

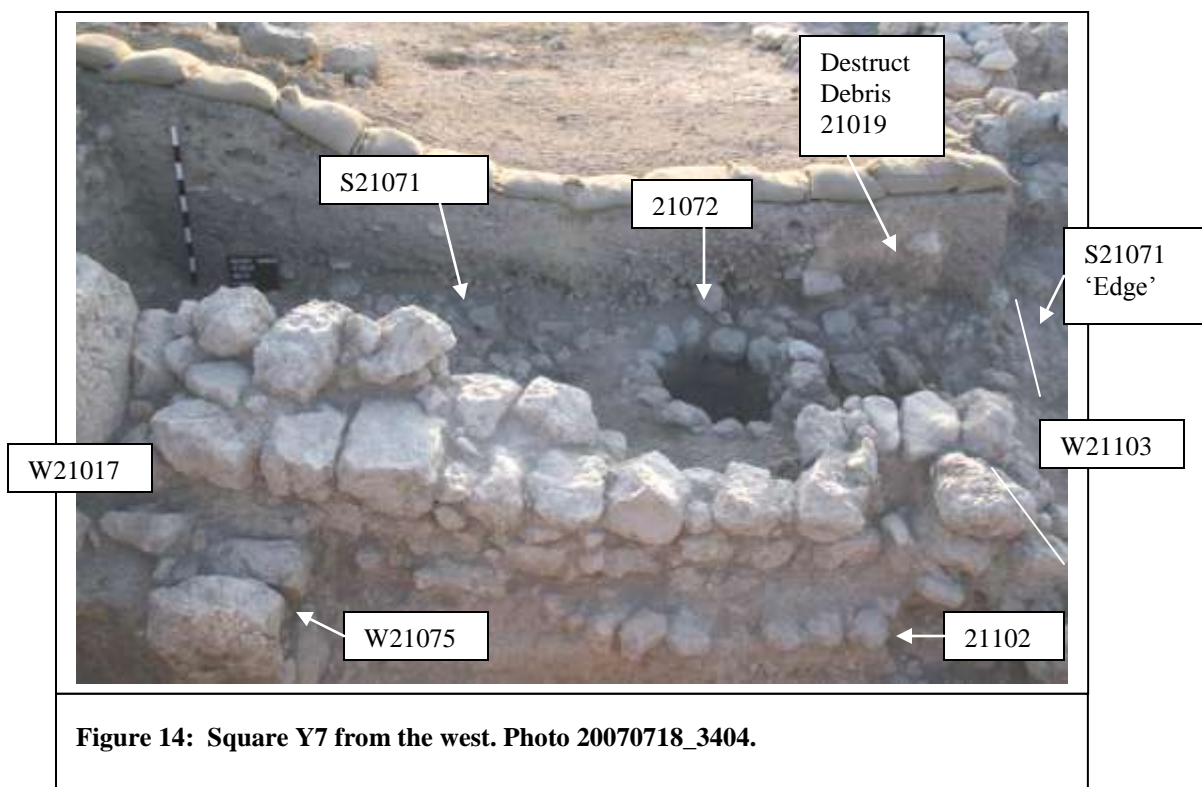
**Figure 14: Square Y7 from the west. Photo 20070718\_3404.**

A small “catwalk” of destruction debris was left by Macalister in the south balk of Y7 (21019; see Fig. 14). This was a small area (.5m x 1m x .4m. deep) and yielded 4 restorable store jars and other pottery. It is consistent with the destruction debris found in Field B.

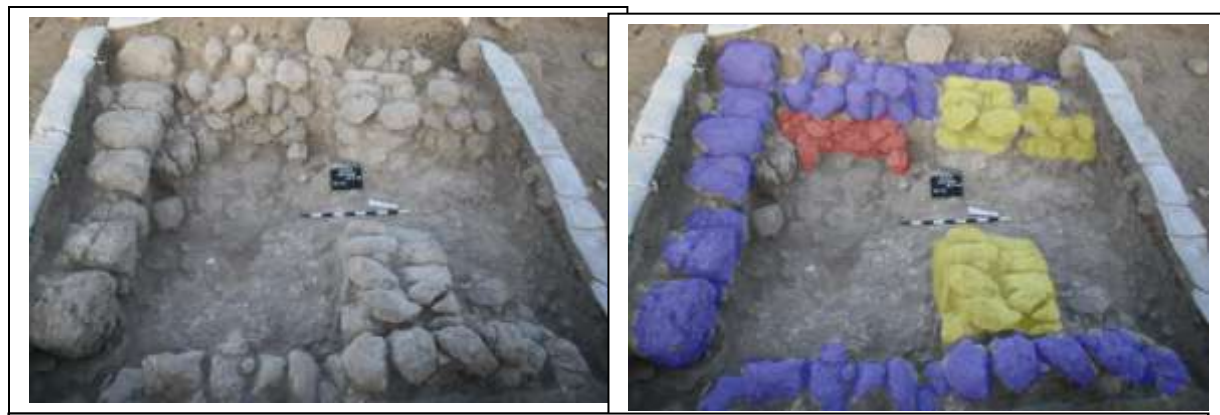
**Figure 16: Room E (Z8 2006) looking W at W11101. Photo 20060615\_0374. Phase 3 (yellow), Phase 6 (blue), Phase 8 (red). Phase 8 material conjectured because the stones are founded below the founding level of W11083, but this may simply be a Phase 6 construction backfill.**

Figures 16 and 17 illustrate the size of this wall. It is possible that the Phase 3 materials replaced earlier stones destroyed or robbed out. It also seems likely that the ‘space’ above the Phase 8 wall (W21101) was originally part of the Phase 6 construction. Thus the total width of this wall would have been 6 rows in Phase 6. The possible reason for this construction is discussed below.

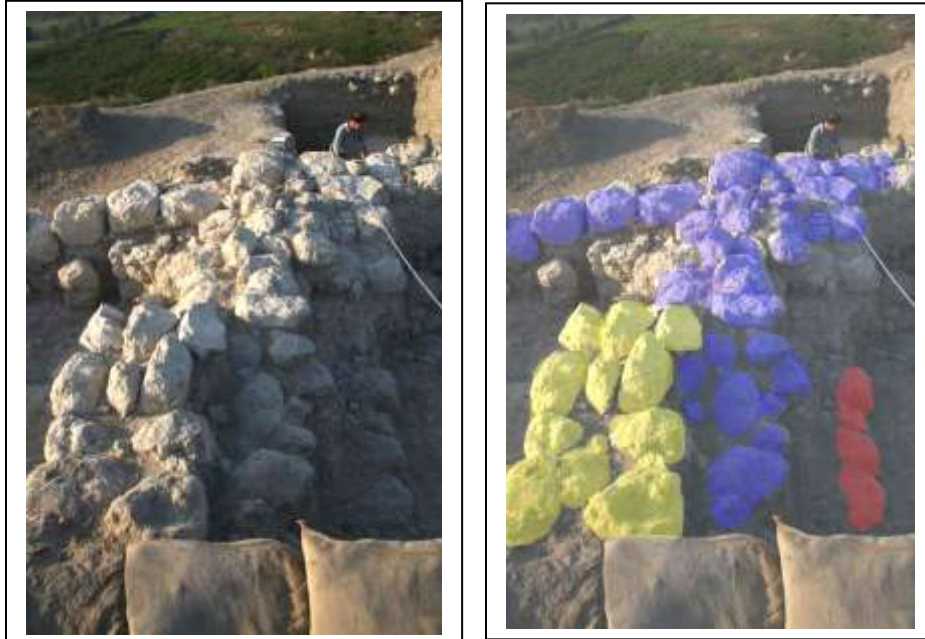
**Figure 17: W11101/21077 (2007) looking south. Photo 20070722\_3548. Phase 3 (yellow), Phase 6 (blue) and Phase 8 (red: W21101)**

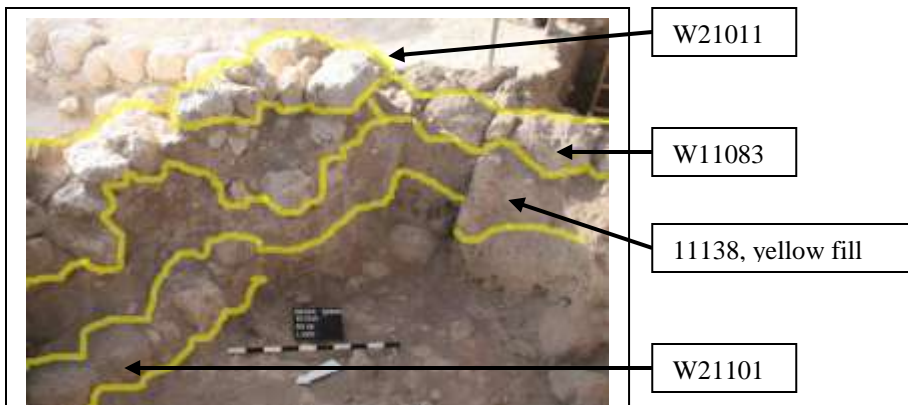
**Figure 18: Southeast corner of Y8 showing the 'yellow' construction fill. Photo 20070713\_3138.**

In Y8/Z8, W21011 was perpendicular to and abutted W11055. It extended northward from W11055 for about 1 meter. It was only one cobble sized stone in width, but was clearly a separate phase above 21077/11101. See Figure 18.

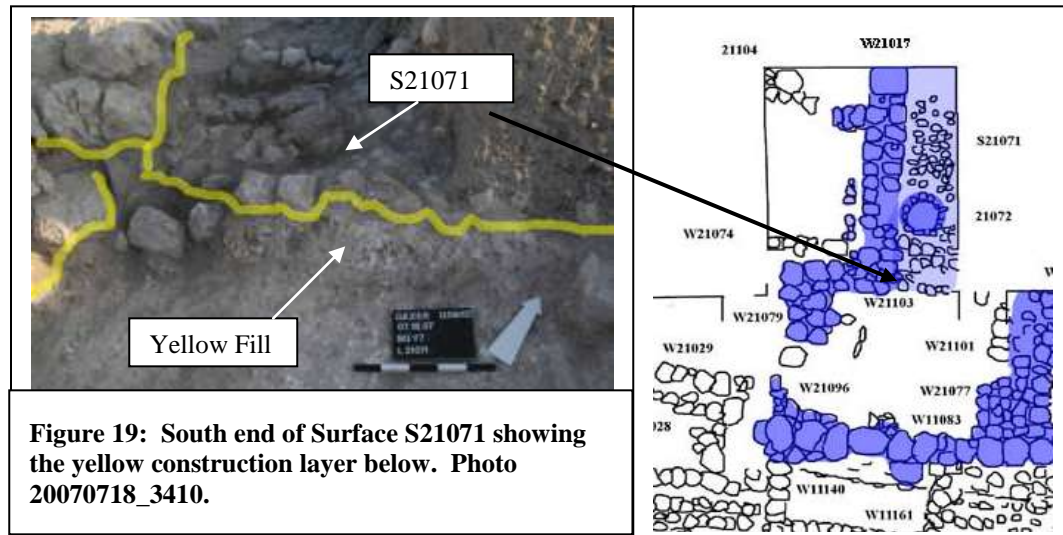
However there is a significant problem with this interpretation. The level of S21071 slopes southward through Y7 ending at the S balk at 215.59. The founding level of W11083 is ca. 215.50. If the surface went across Y7 it would have had to slope upward to ca. 216.00 (after sloping down at about the same angle -- see Figure 19, in red). This does not seem reasonable.

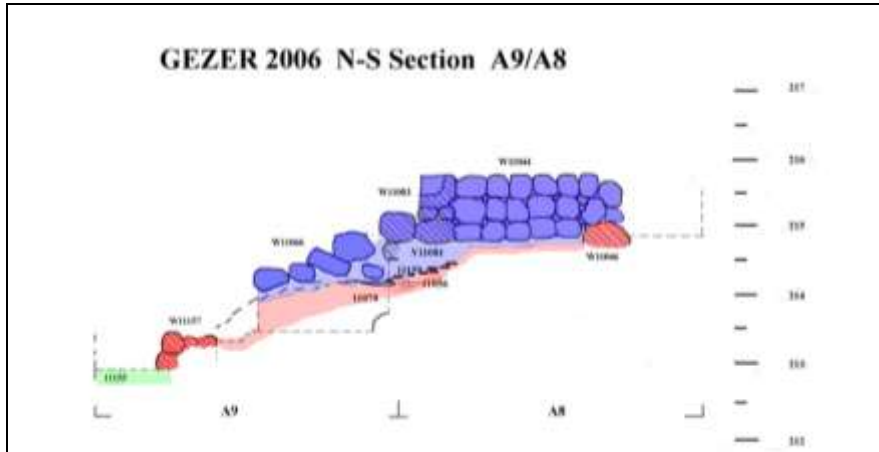
**Figure 23: Section through A9-A8 . The material immediately under W11083 is conjectured based on the other elements.**

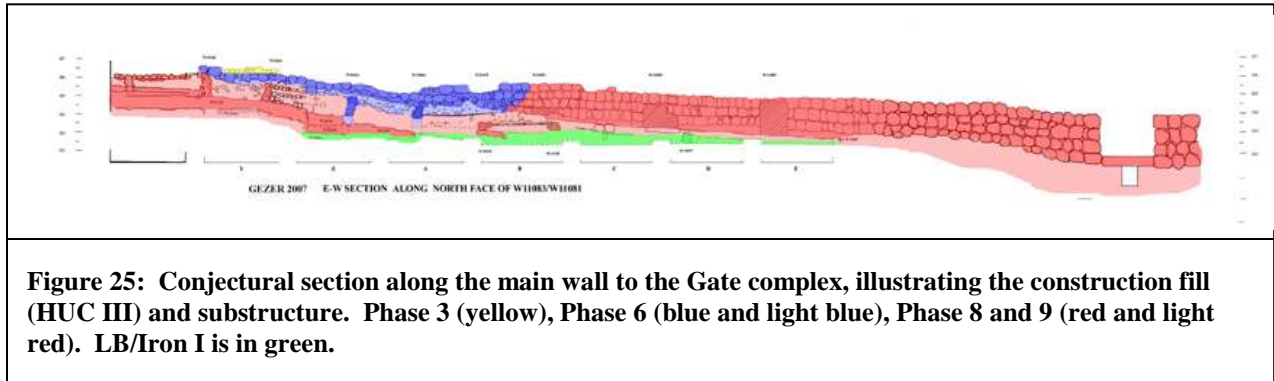
**Figure 25: Conjectural section along the main wall to the Gate complex, illustrating the construction fill (HUC III) and substructure. Phase 3 (yellow), Phase 6 (blue and light blue), Phase 8 and 9 (red and light red). LB/Iron I is in green.**

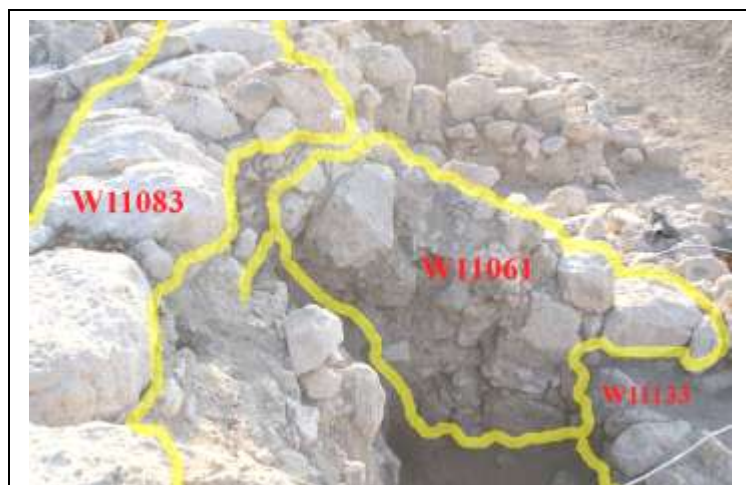
**Figure 27: Y9 from west showing the relationship of the wall system. Photo 20070722\_3550.**

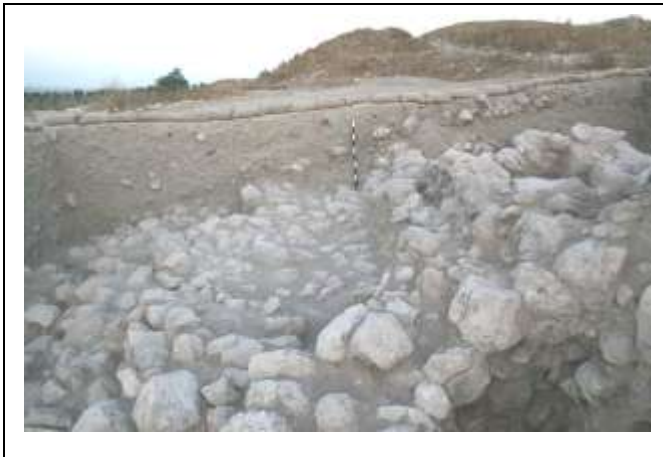
**Figure 29: West balk of W9 and W8 showing the interrelatedness of the stone 'mantle' to the retaining wall system. Photo 20070718\_3470.**

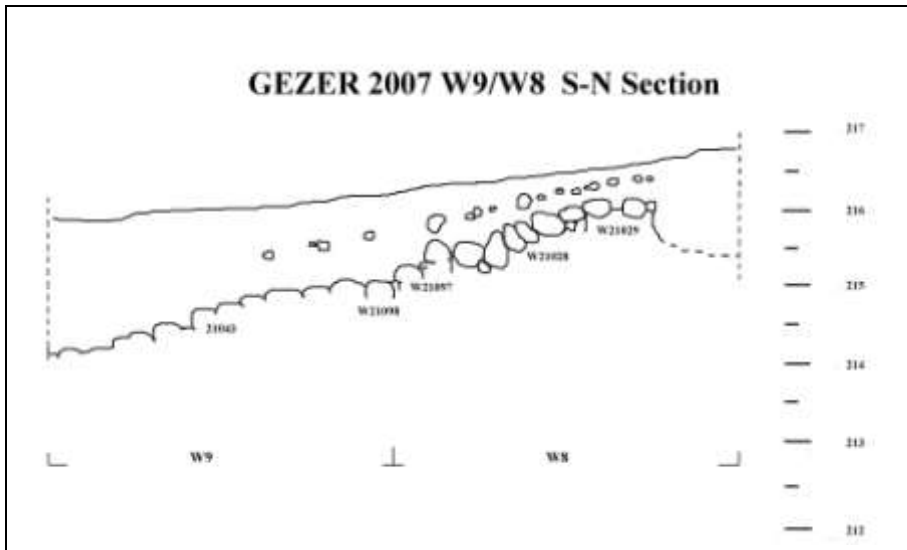
**Figure 30: Section W9-W8 showing slope and relationship of stone 'mantle' to retaining walls.**

**The nature of this entire system can now be postulated. It served to structurally reinforce the slope of the tel, provide a socle foundation for the wall above and create a measure of defensibility through the stone mantle.** Its dating is discussed below.

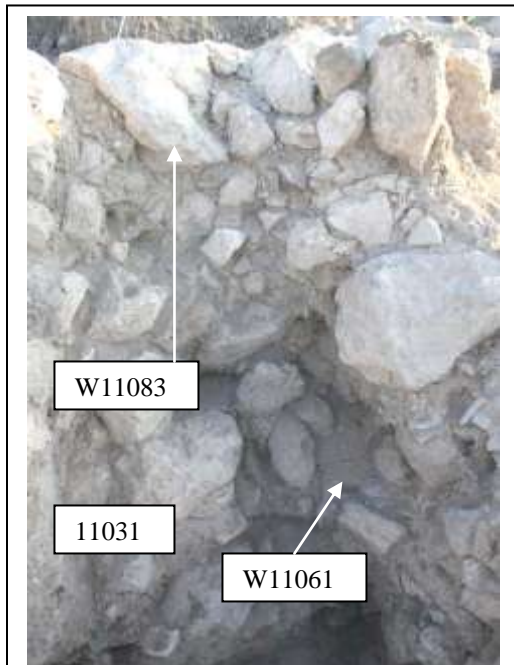
**Figure 33: Relationship of rib wall W11061 to W11083. Photo 20070722\_3355.**

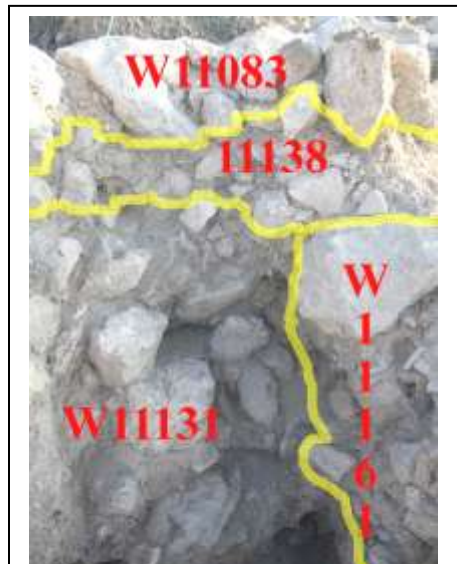
**Figure 34: The connection between W11161 and W11083, postulating the fill 11138 between them. Photo 20070722\_3355**
